Diagnostica per la Valutazione della Vulnerabilità di Ponti in Cemento Armato

Dario Foppoli
Foppoli Moretta e Associati
Tirano (SO) – ITALY
posta@foppolimoretta.it
www.foppolimoretta.it

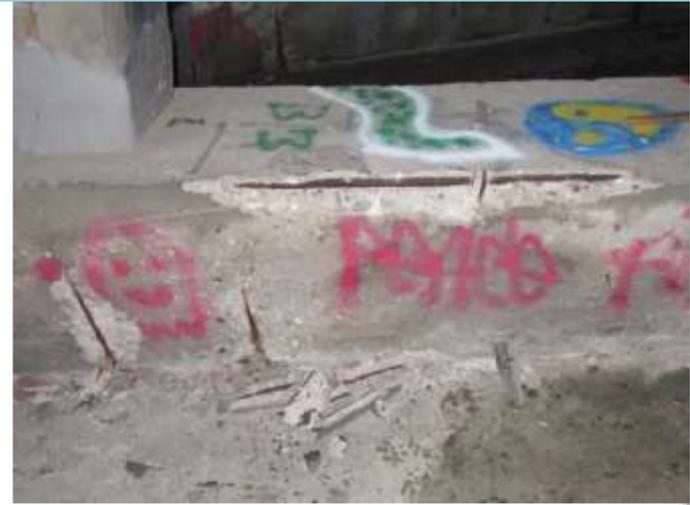
Spalling of the concrete cover of an arch

Spalling on the brackets and longitudinal bars

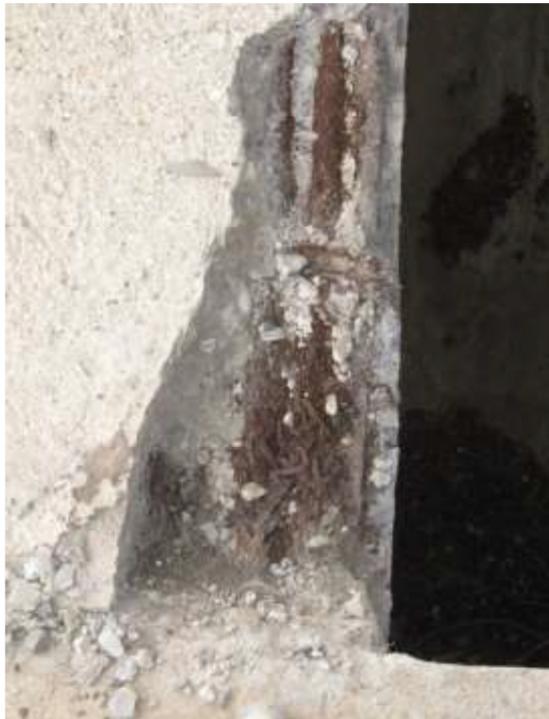
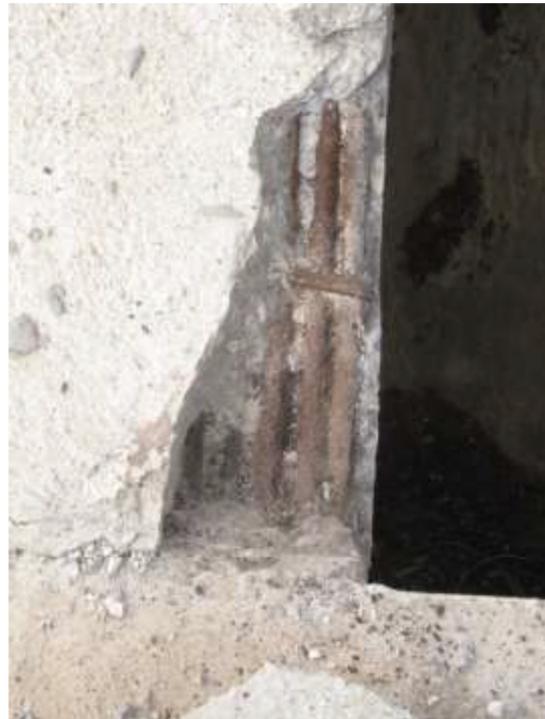
Steel oxidation resulting in the rupture of the concrete cover - arch

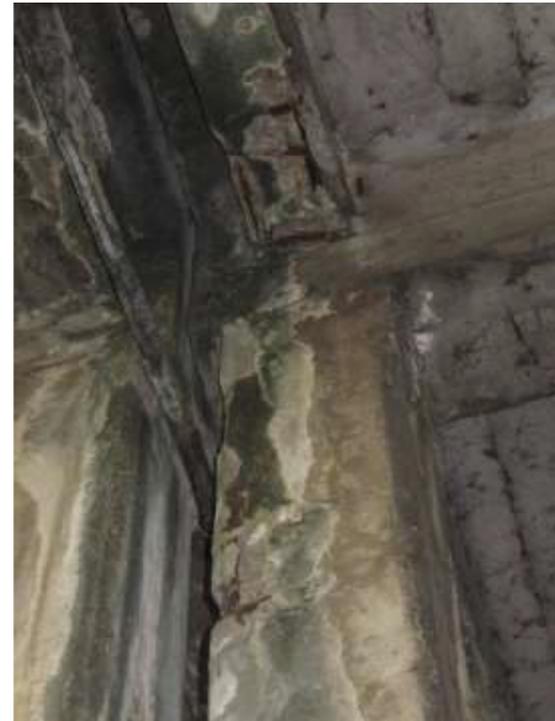
Degradation of the shelves close to the position of the joint

Degradation due to the expansion joint

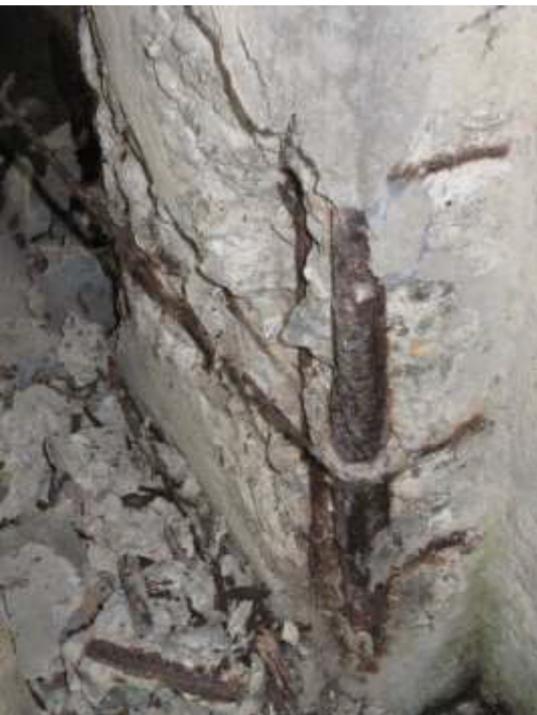
Oxidation of the bars of a pillar and spalling close to the position of the expansion joint

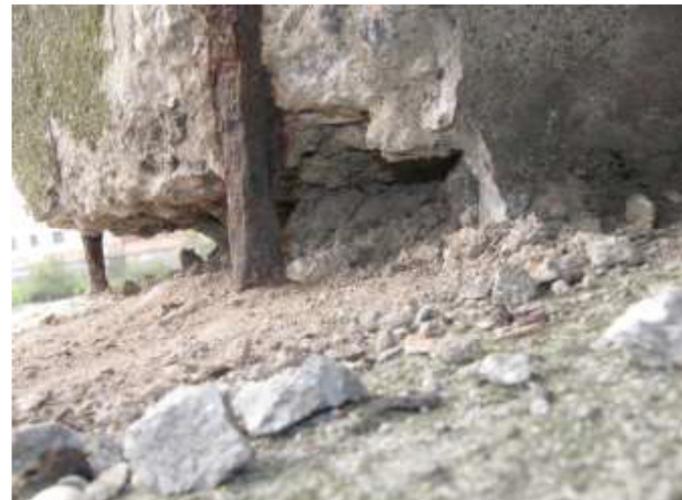
Deterioration of the section at the basis of a pillar: bar almost completely oxidized

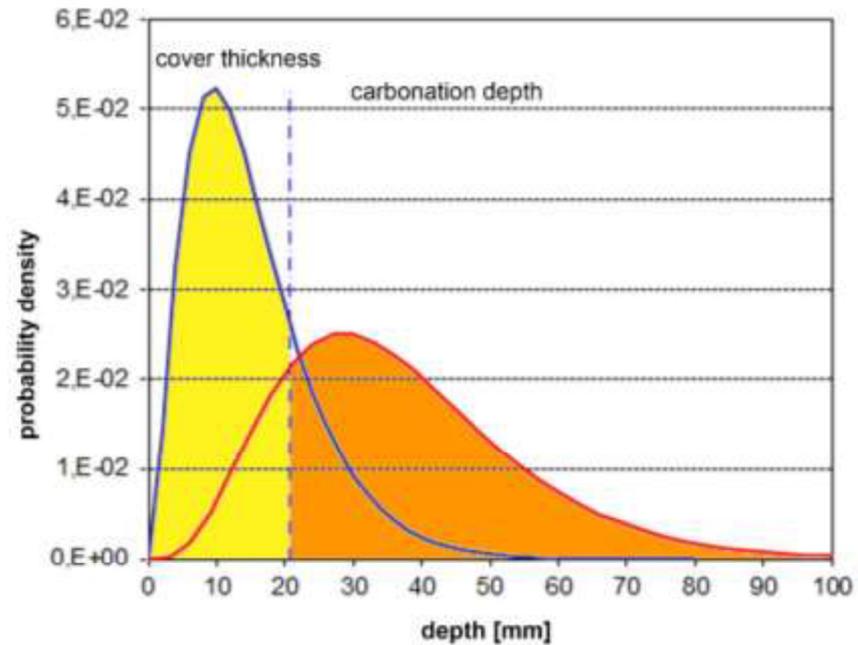
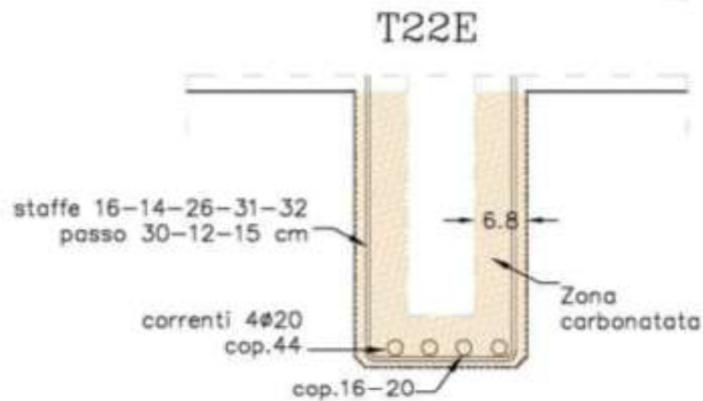
Normal distribution
stirrups cover thickness vs carbonation depth

Because of carbonation, rebar lies in an environment which allows their corrosion

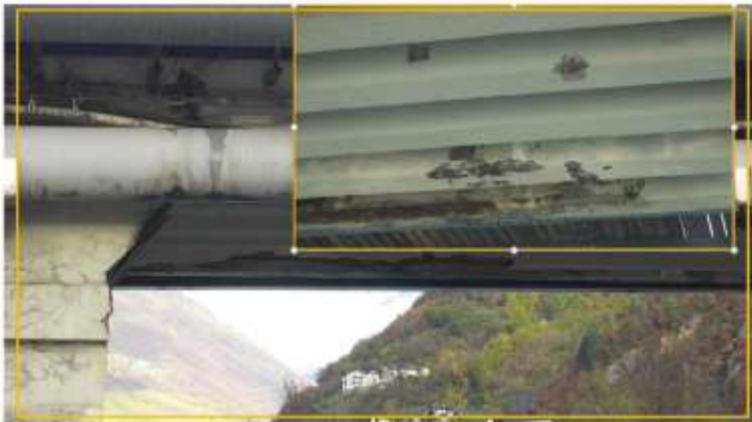
Foto 5 – Arcata 1, Lato valle

Descrizione: Espulsione dei ferri, dettaglio.

Suggerimenti: Si raccomandano incisivi interventi di ripristino nelle aree soggette a percolazione tramite sabbatura delle parti delle armature esposte e protezione delle stesse con l'uso di un passivante ed il ripristino dell'elemento portante.

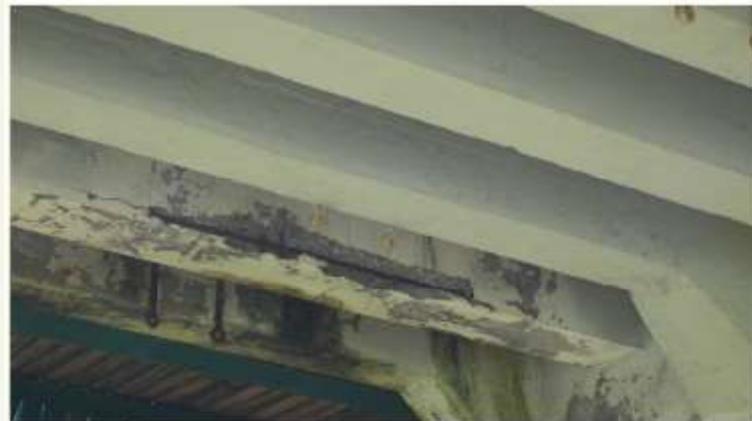
Foto 9 – Arcata 2, impalcato

Descrizione: Espulsione del ferro ed erosione dell'impalcato.

Suggerimenti: Si raccomandano incisivi interventi di ripristino nelle aree soggette a percolazione tramite sabbatura delle parti delle armature esposte e protezione delle stesse con l'uso di un passivante ed il ripristino dell'elemento portante.

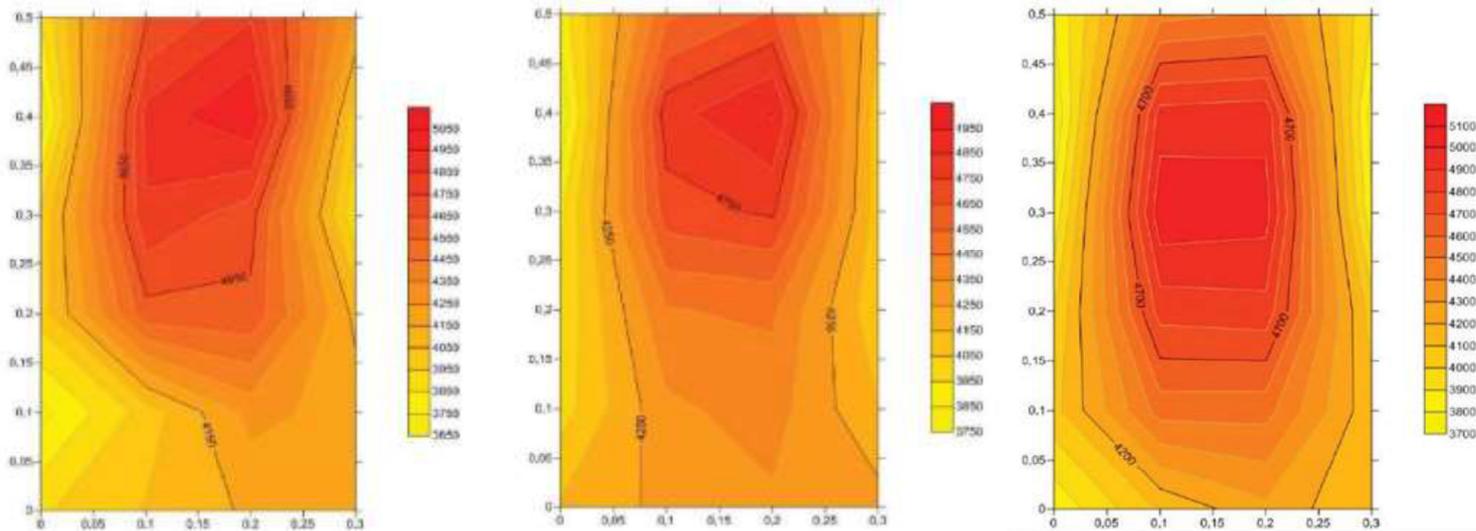
UT velocities are lower in the cortical part of the beam: this distribution highlights the lower density of the cortical concrete (if compared to the nucleus). This could be correlated to the constructive technologies of the time (beginning of the 20th century), for example to a poor attention to the vibration during the casting or to the environmental conditions during the curing.

Tomographic sketch of the 1st phase beams (cross section)

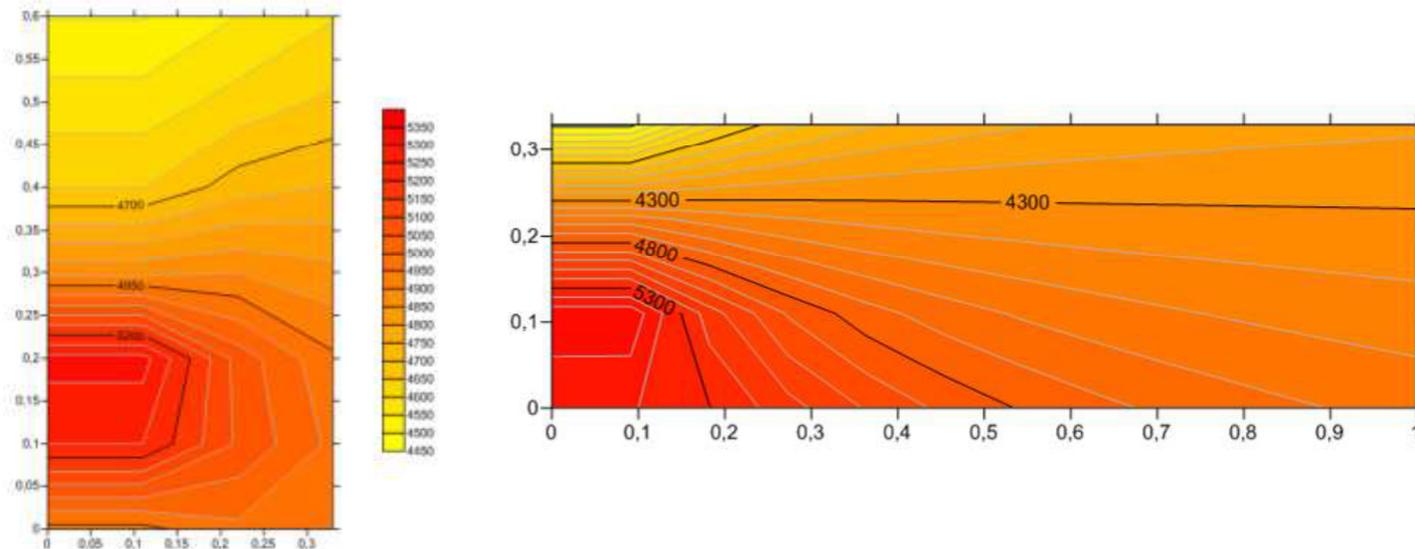
UT velocities are higher in the lower part than in the upper part of the beam: in this case this can be related to the presence within the core of concrete of metal elements, which geometry, however, was not possible to determine with this methodology.

Tomographic sketch of 2nd phase beams (cross section and horizontal)

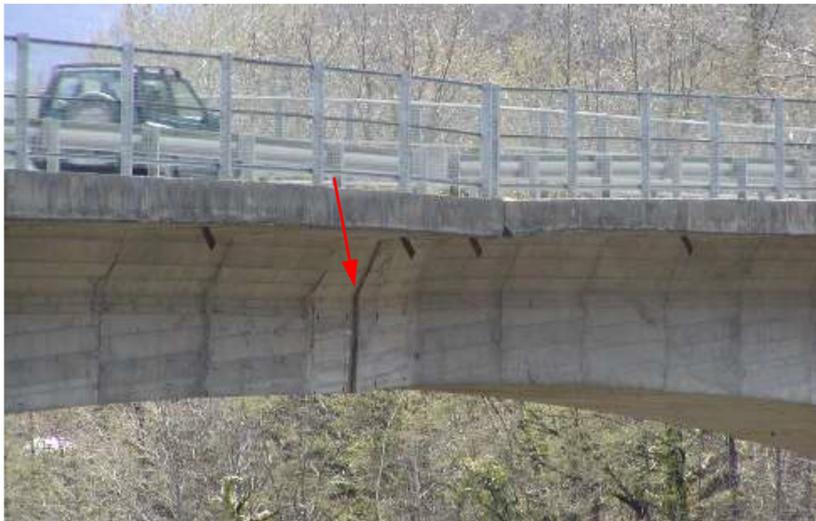
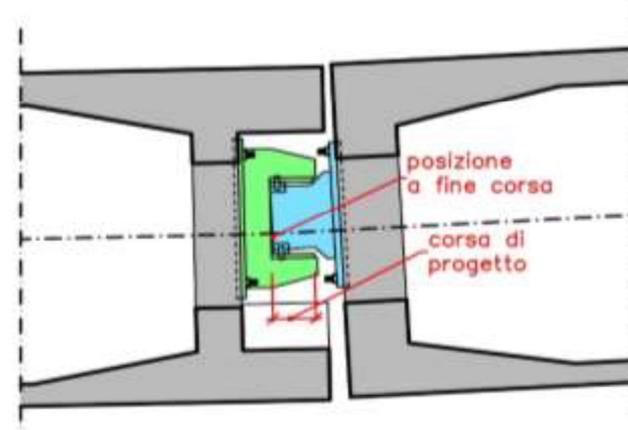
survey of the upstream side contact device (longitudinal section)

PROBLEMS: safety hazard and low comfort for transiting vehicles
dynamic stress on structures due to impact of mobile loads, social problem

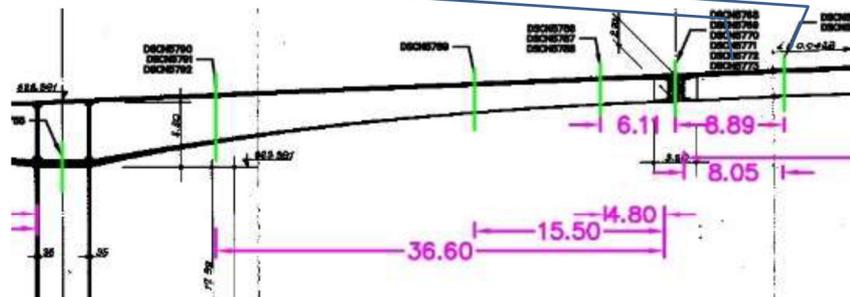
cracks at extrados of the
deck along casting recovery
lines

PROBLEMS: modification of constraint conditions, actual conditions different from design conditions, potential unexpected failure kinematism
