Diagnostica per la Valutazione della Vulnerabilità di Ponti in Cemento Armato

Dario Foppoli
Foppoli Moretta e Associati
Tirano (SO) – ITALY
posta@foppolimoretta.it
www.foppolimoretta.it

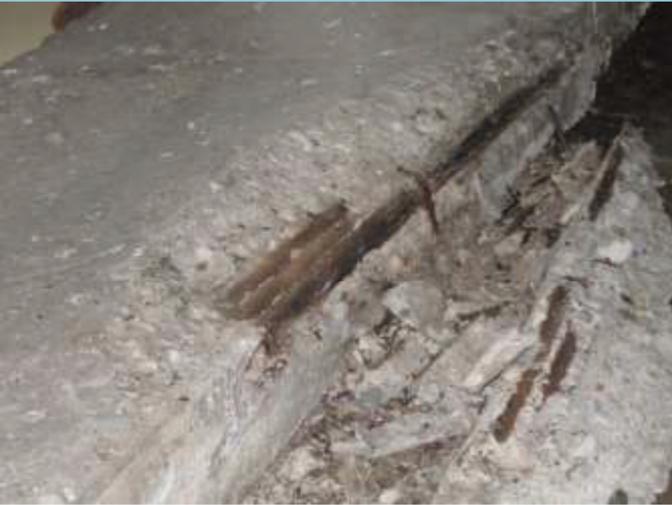
Spalling of the concrete cover of an arch

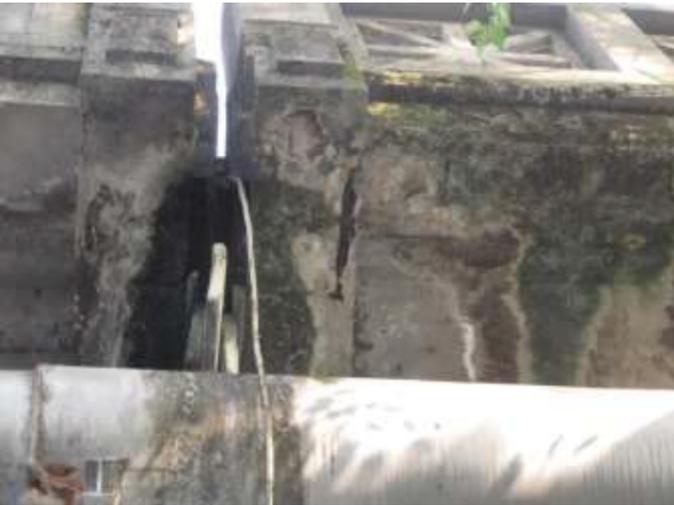
Degradation of the shelves close to the position of the joint

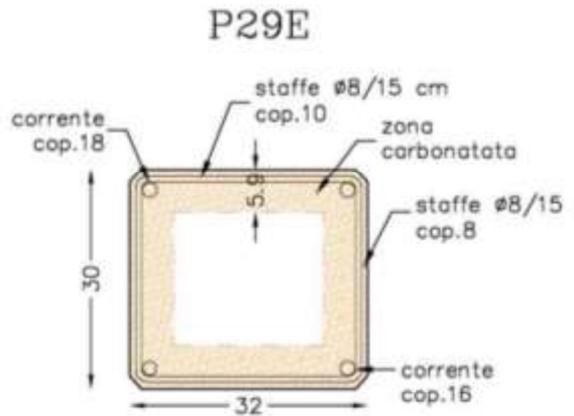
Normal distribution
stirrups cover thickness vs carbonation depth

Because of carbonation, rebar lies in an environment which allows their corrosion

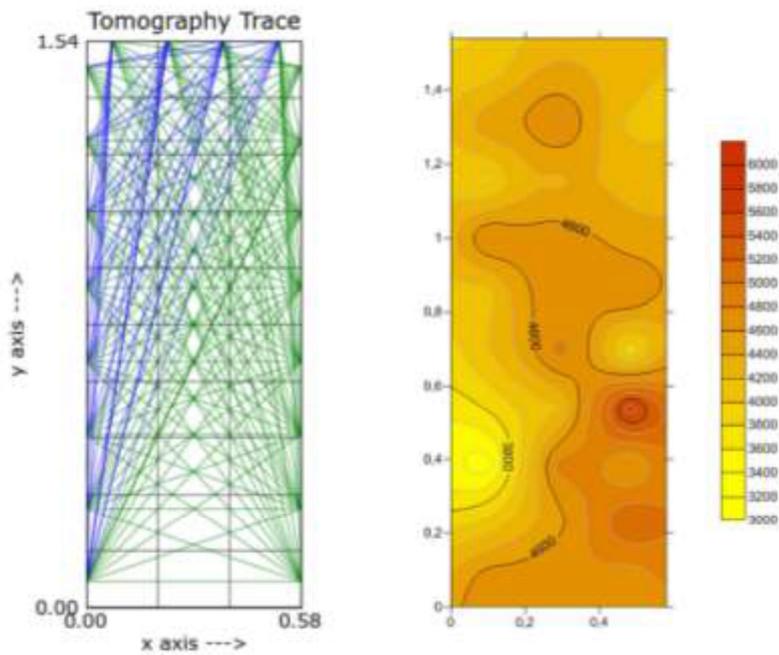
Arcone A4C

Maximum speed: 5739.0 m/s
Minimum speed: 3275.0 m/s
Average speed: 4462.0 m/s

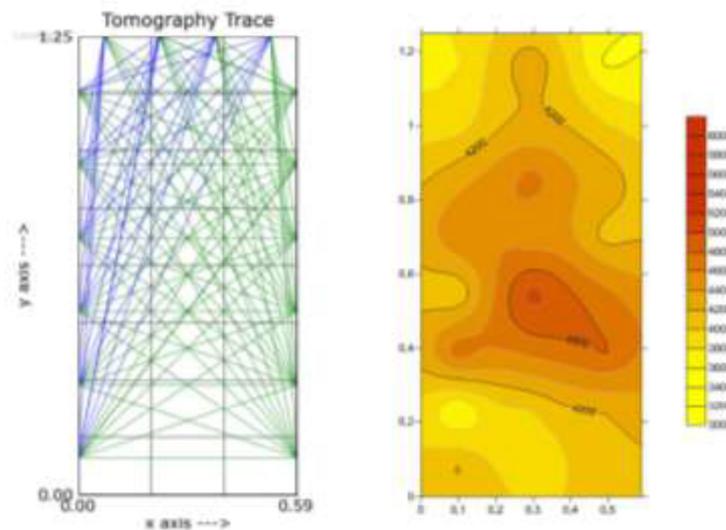
Arcone A5C

Maximum speed: 5084.0 m/s
Minimum speed: 3565.0 m/s
Average speed: 4261.0 m/s

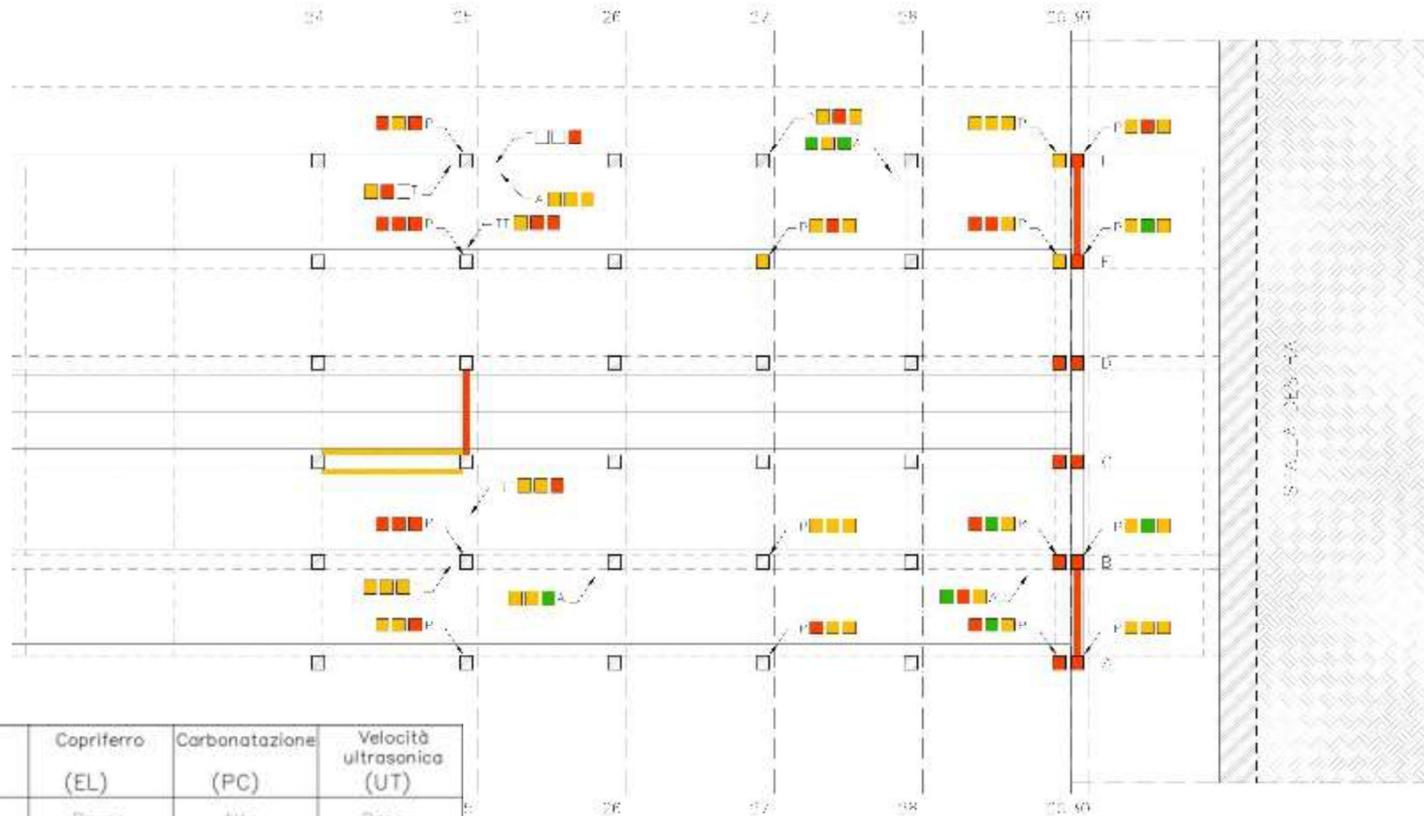
ARCONE DESTRO SPALLA DESTRA

Synoptic tables showing the R.C. structures degradation status

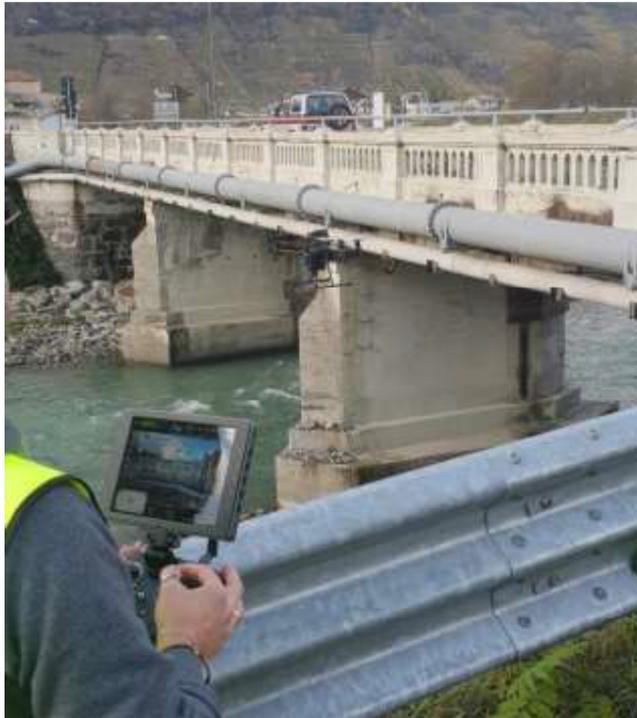
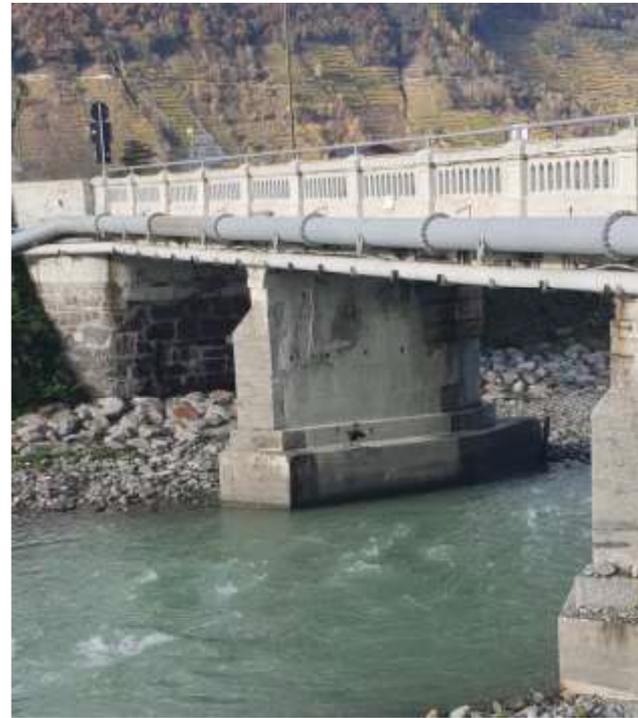
Visual Inspection (**VT**) allowed to detect a bad general maintenance and conservation status. The major degradation phenomena observed are exfoliation of the superficial layers of the concrete on the shoulders and spalling of the concrete cover on the beams of the deck, due to percolation and high humidity. Spalling phenomena are progressive and require to restore the section as soon as possible.

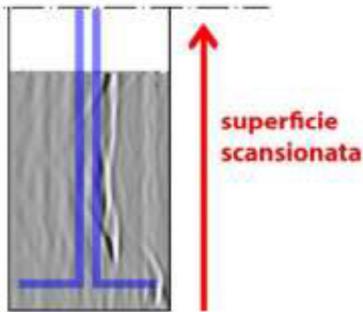
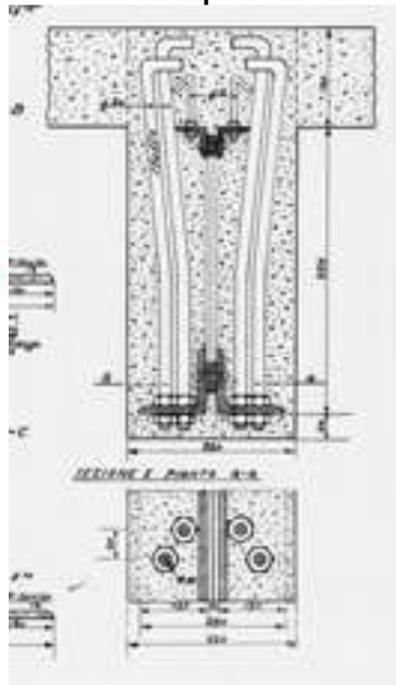
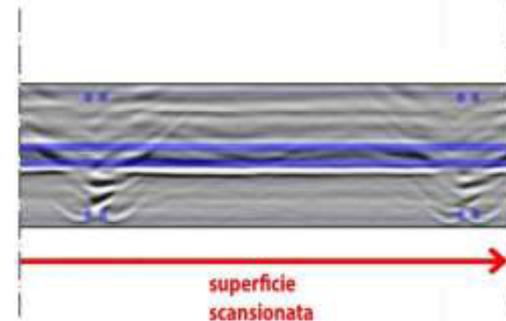
Cross section – hypothesis vs original design sketch – Longitudinal section

It is possible to suppose the existence of steel elements L or C shaped within the core of the concrete beam. It was detected the lower lintel and the vertical core; in some survey the core seem not to be continuous. The lower lintel is also connected to the upper concrete slab by means of a couple of ties placed at a distance of 100 cm from each other.

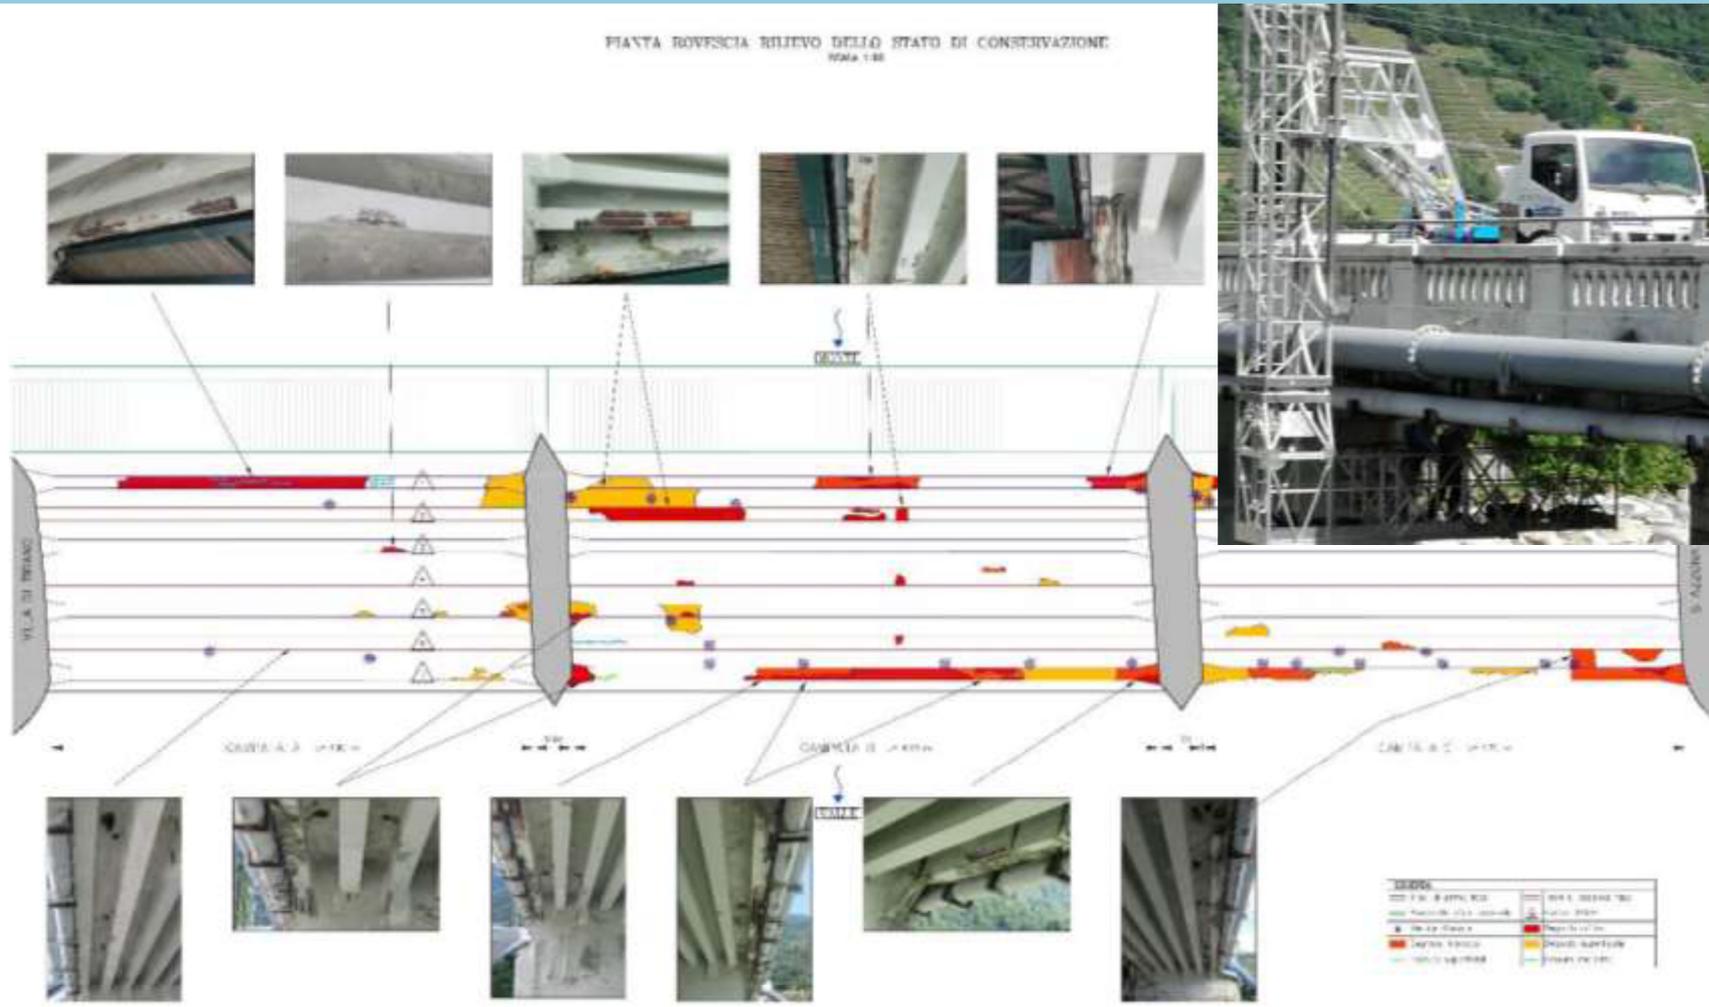
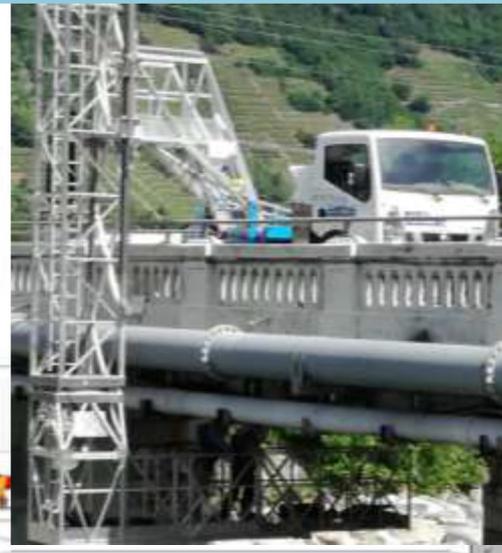
Direct Visual Inspection of the Conservation Status

Visual survey: identification of corrosion of the steel elements and expulsion of the concrete cover

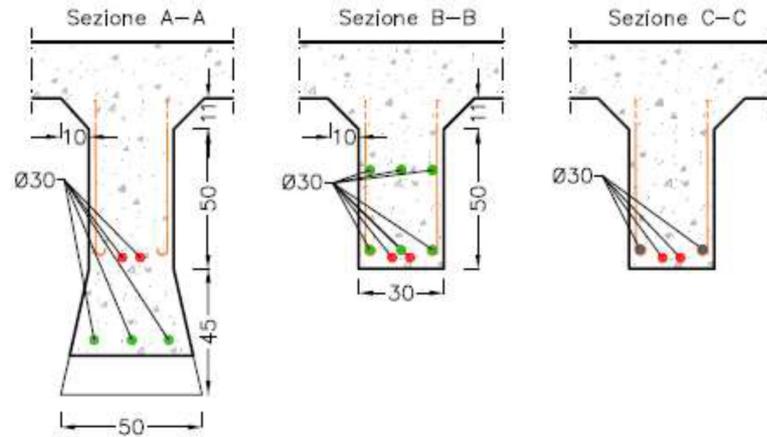
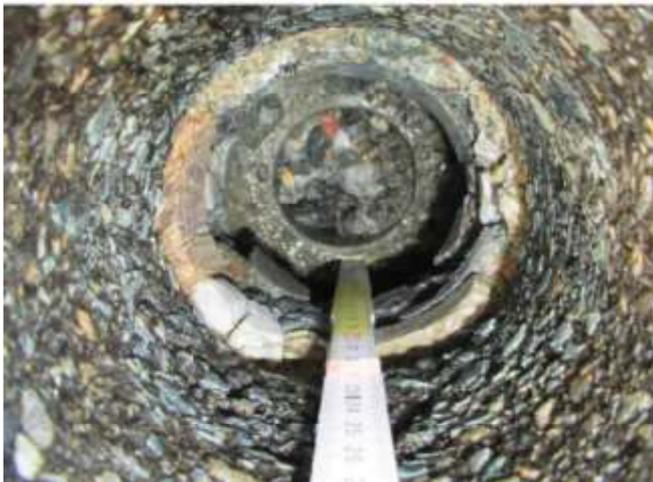
SEZIONI
- scala 1:20 -

1st phase beams - Reinforced bars in the cross sections;
endoscopic survey within little coring holes

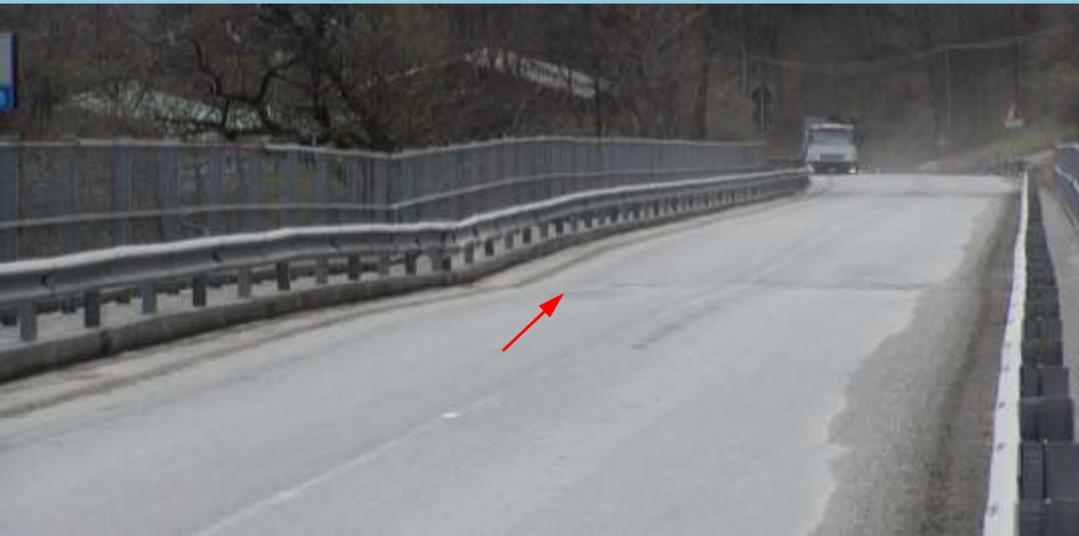
FUNCTIONAL ISSUES

- transversal dip on the road above the central link (13,8 cm)
- improvement of protection of safety fence

PROBLEMS: safety hazard and low comfort for transiting vehicles
dynamic stress on structures due to impact of mobile loads, social problem

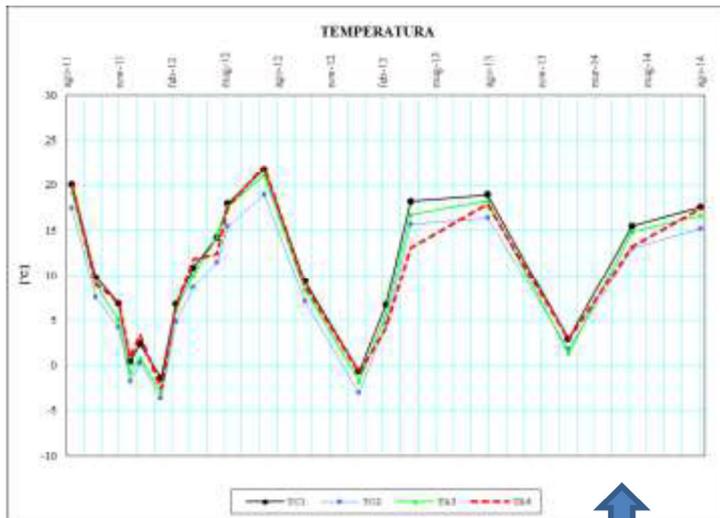
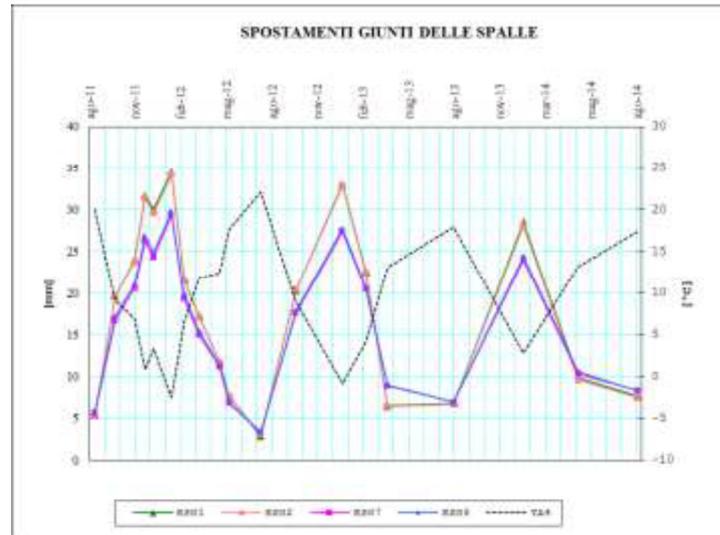
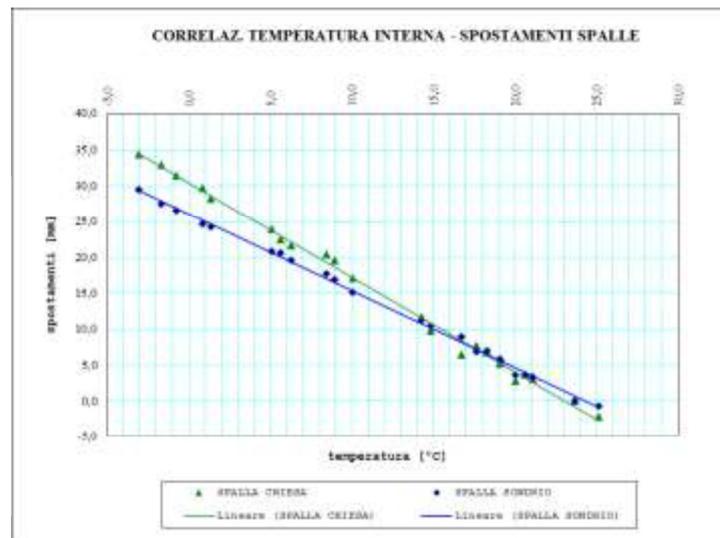
Diagrams – Temperature and Abutments Joints

- thermal gradient
Structure T vs External Air T = $\pm 5\text{ }^{\circ}\text{C}$
Structure T vs Internal Air T = $\pm 2\text{ }^{\circ}\text{C}$
- average displacement of abutments joints are phased with each other and counter phased with the temperature:
- Coefficient of the Linear Regression is sound ($R^2 = 0,996-0,997$)
- as the temperature increases, the abutments joints closes, as expected on the basis of structural considerations.

Overall displacement of the bridge deck is therefore directly related to the thermal forcing without presenting drift phenomena over time

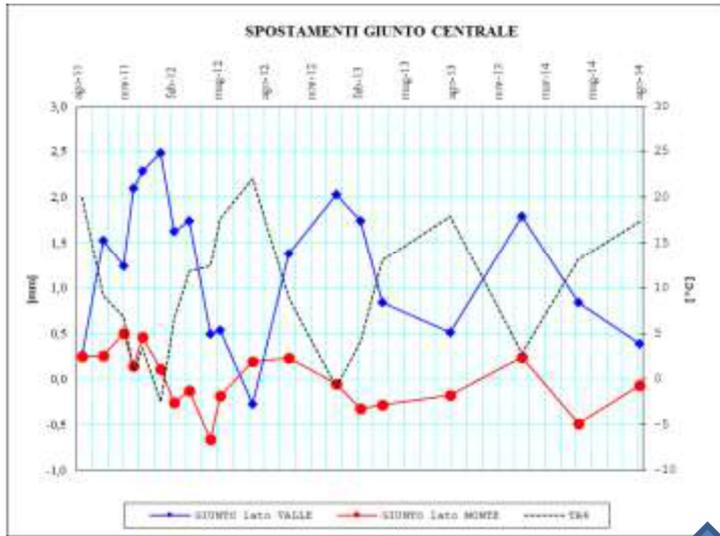
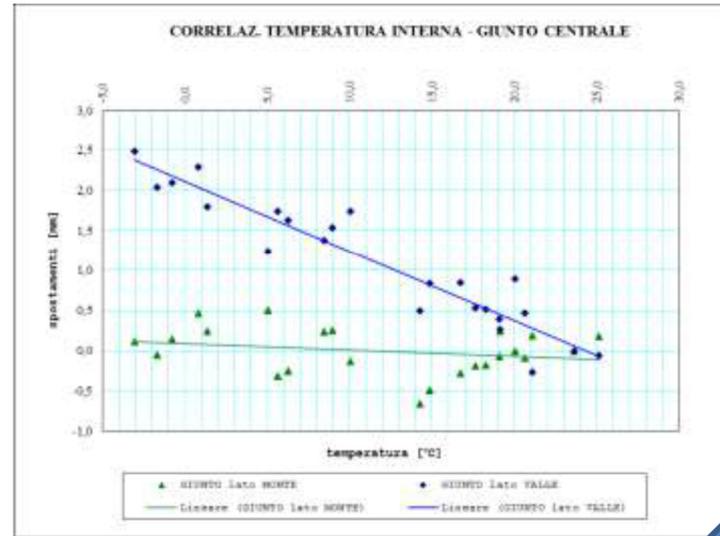
Diagrams –Key Joints

- Upstream side key joint displacement is counter phased with the temperature as expected on the basis of structural considerations.
- Downstream side key joint displacement is irregular – upper and lower displacements are sometimes discordant

- The linear regression of displacement of upstream side key joint has a Coefficient of the Linear Regression ($R_2 = 0,896$) lower than the previous one
- For the downstream side key joint the quality of the regression is poor, so confirming the inadequacy of its structural behavior

The data confirms that the downstream key metal joint is at the end of its stroke and does not operate correctly neither with the reduction in length of the deck in correspondence with low winter temperatures.

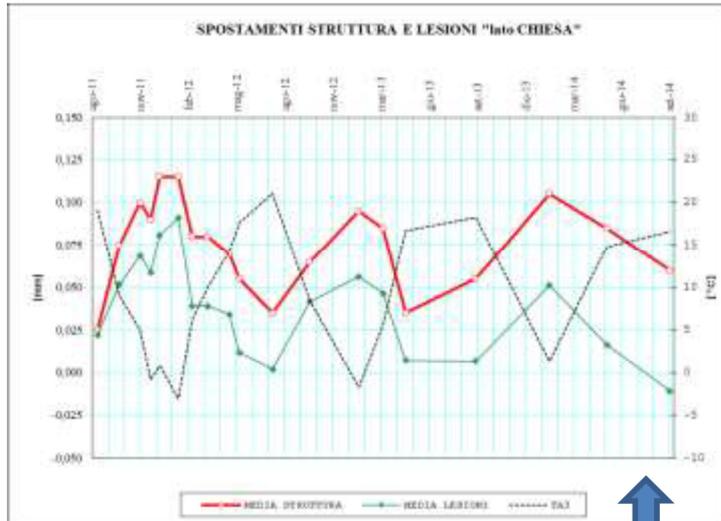
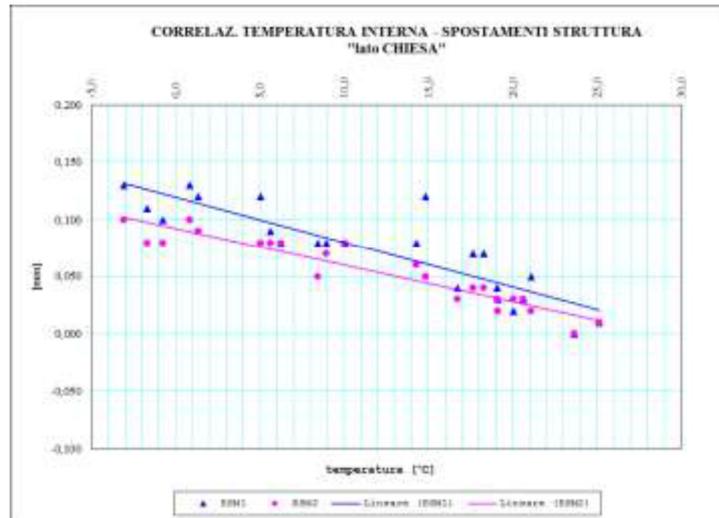
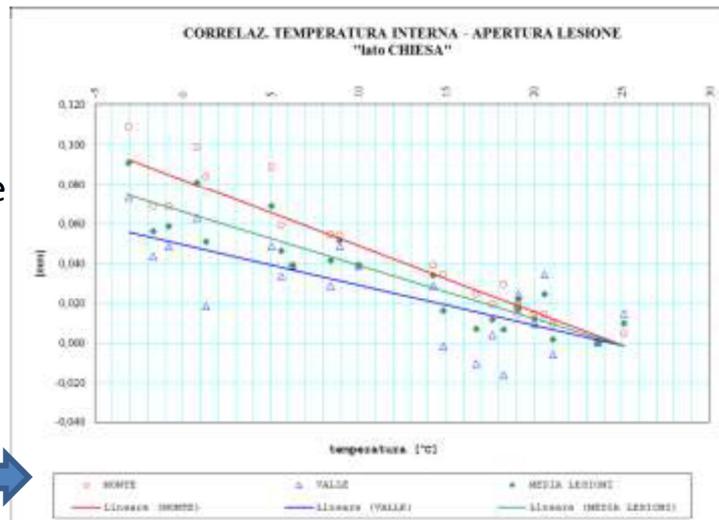
Diagrams – Cracks Behaviour

- concrete deformation is counter-phased with the temperature – good Correlation Coefficient
- crack opening variation is counter-phased with the temperature (max displ. 0,1-=-,2 mm): as the temperature increases, there is in fact a greater hyperstatic compression (or less hyperstatic traction) and therefore a closure of the lesion
- linear regression between crack opening and thermal forcing is not really satisfactory in this last case ($R^2 = 0.560 \div 0.877$)

It is possible to suppose that the internal actions responsible for the openings are combined to other entities (e.g. upstream/downstream, top/bottom temperature gradient, wind) or that the phenomenon is not stable and has a drift.

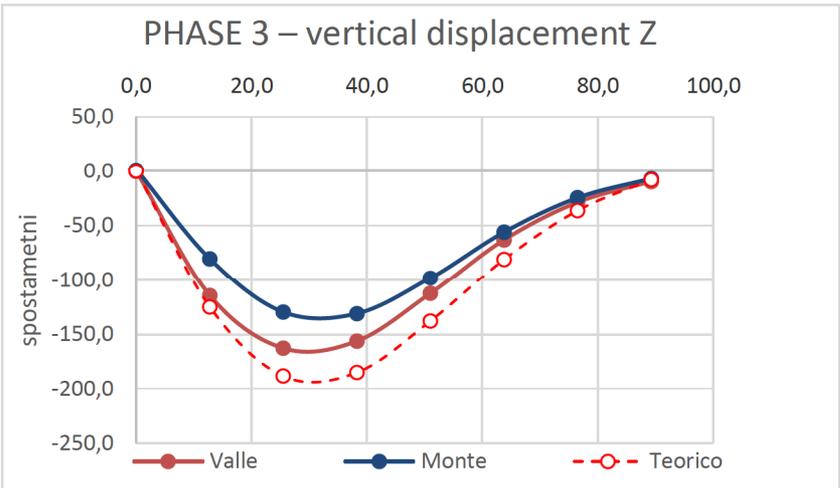
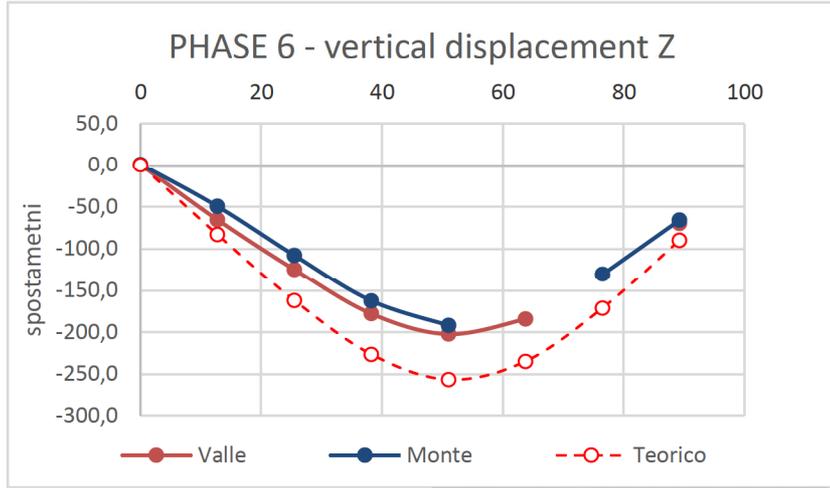
Static Load Test

- STATIC LOAD TEST:
- Loading - trucks
 - Measurement - topographic motorized total station – 16 measuring positions

DIFFERENT LOAD PATTERNS EACH APPLIED IN SEVERAL LOADING PHASES

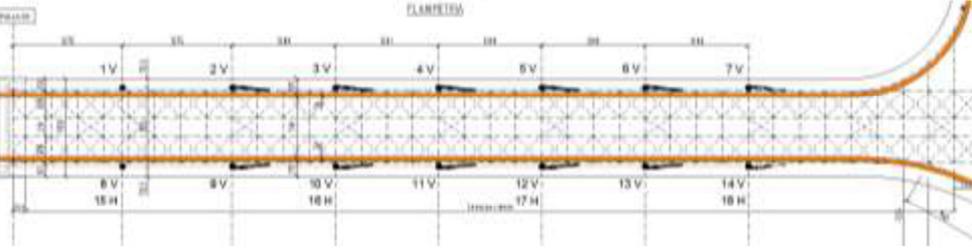
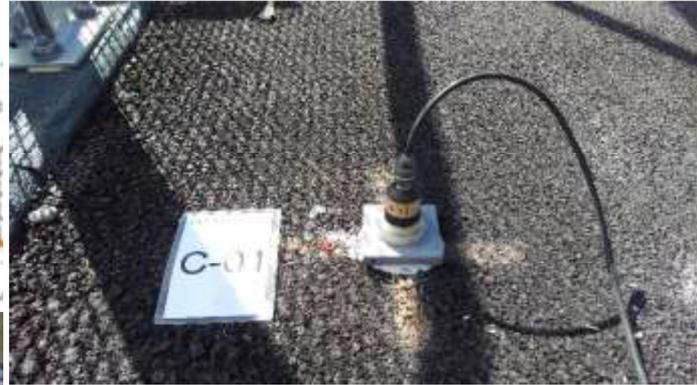
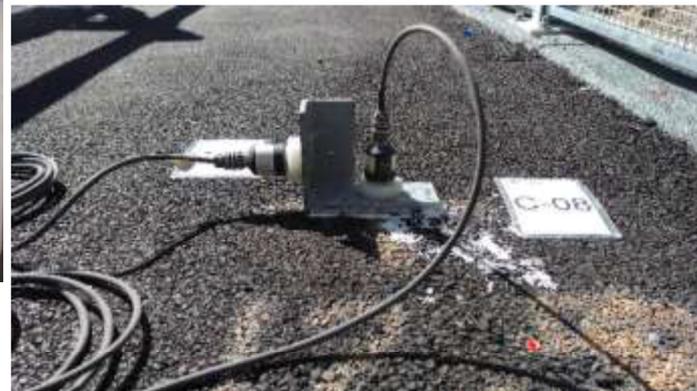
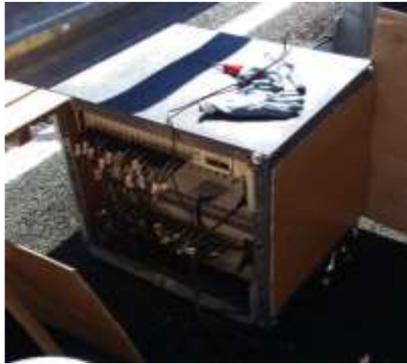
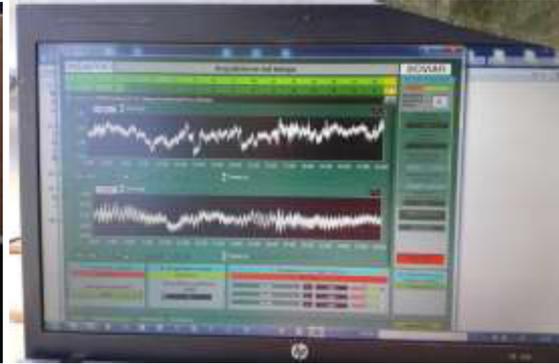
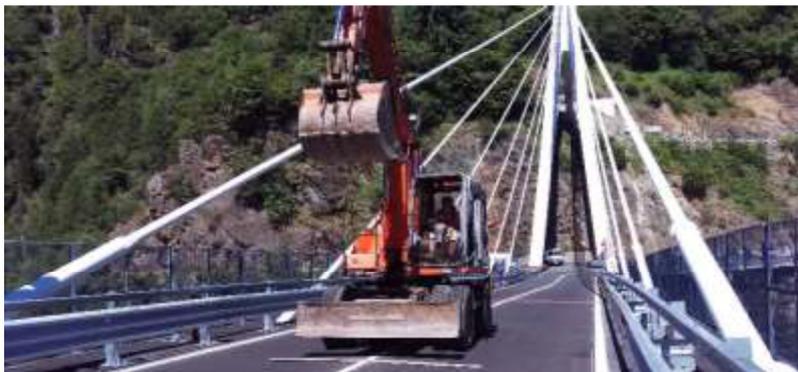
Dynamic Characterisation

14 vertical measuring positions; 5 horizontal

- environmental noise
- forcing with motor vehicle

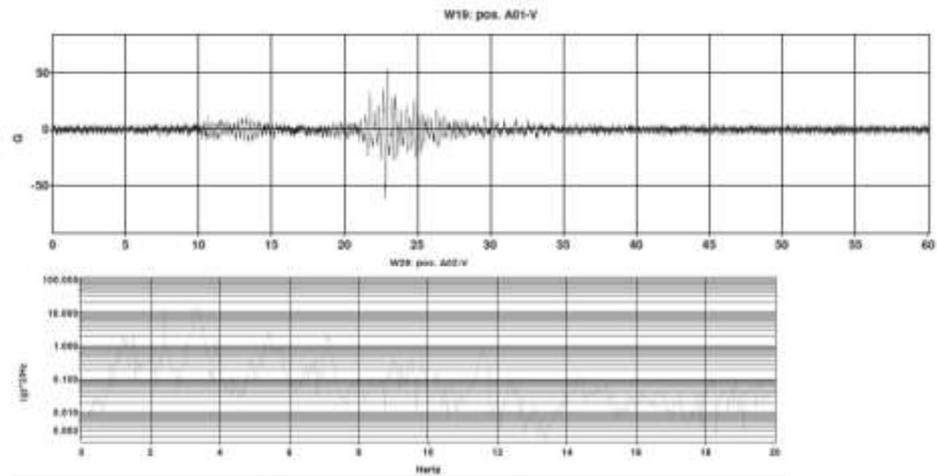
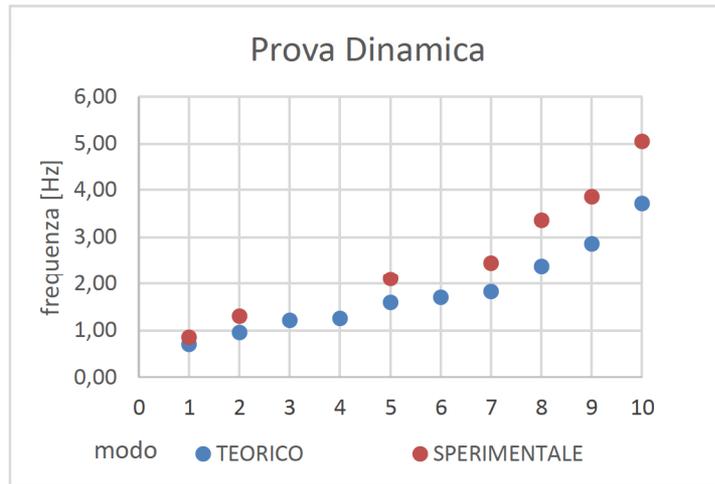
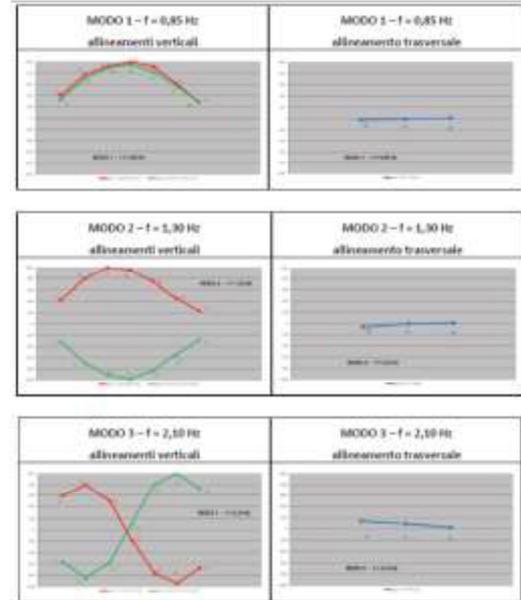
OUTPUT OF DYNAMIC TEST

modo n°	TEORICO		rilevato n°	SPERIMENTALE		modo teorico corrisp.	rapporto frequenza teor./sper.
	periodo s	frequenza Hz		periodo s	frequenza Hz		
1	1,44	0,69	1	1,18	0,85	1	82%
2	1,05	0,95	2	0,77	1,30	2	73%
3	0,83	1,20	3	0,48	2,10	5	76%
4	0,80	1,25	4	0,41	2,45	7	74%
5	0,63	1,59	5	0,30	3,35	8	71%
6	0,59	1,69	6	0,26	3,85	9	74%
7	0,55	1,82	7	0,20	5,05	10	73%
8	0,42	2,38	8	0,19	5,40	-	-
9	0,35	2,86	9	0,14	7,05	-	-
10	0,27	3,70	-	-	-	-	-
